# Effectiveness of waste plastic bottles as construction material in Rohingya displacement camps

Md. Sazzadul Haque<sup>a,b,\*</sup>, Shabab Islam<sup>a</sup>

<sup>a</sup> Department of Civil and Environmental Engineering, North South University, Dhaka, 1229, Bangladesh

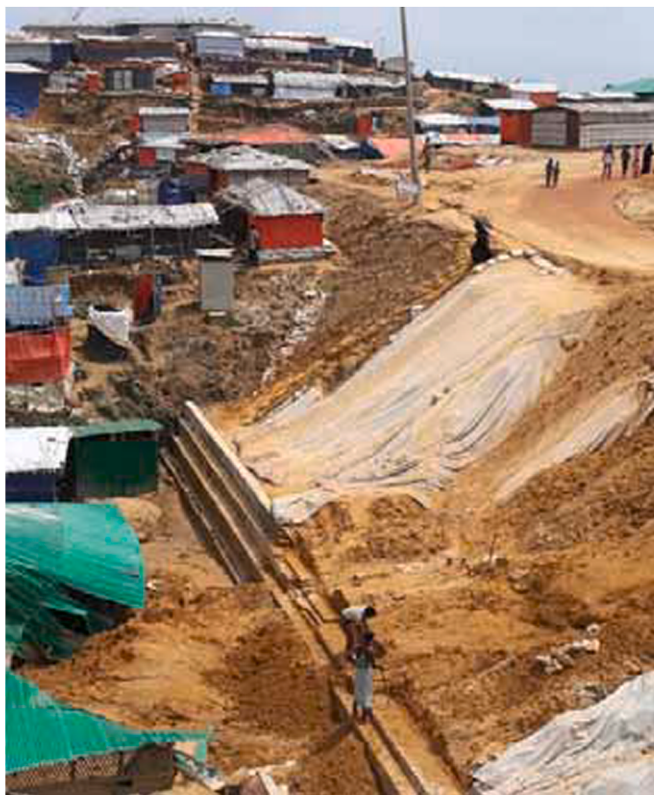
Fig. 2. After a night of heavy rainfall event, a health care center was destroyed in Kutupalong-Balukhali camp - the largest refugee camp of the world - due to a rainfall induced landslide (HPN, 2018).

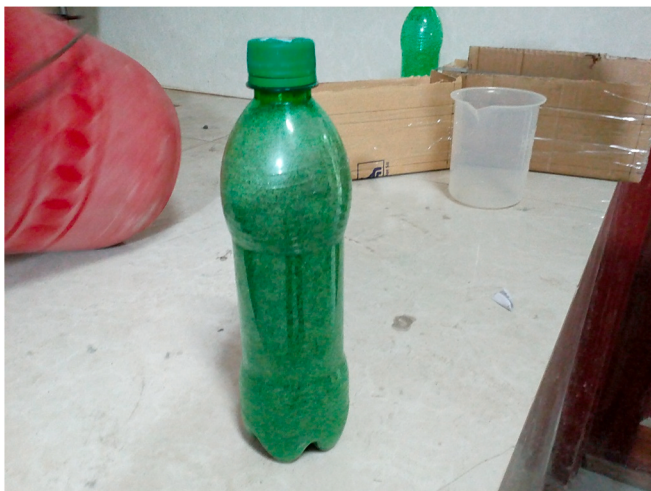
Fig. 5. A sample 500 mL waste PET plastic bottle fully compacted with sand as the filler material and tightly sealed with a cork.

The plastic brick for this study was prepared by utilizing a 500 mL PET waste plastic bottle, utilizing sand as the filler material. At first the 500 mL bottles were washed properly with freshwater and dried before proceeding to the next step. After that, with the help of a funnel fine sand was poured in these sample bottles fully and compacted in three layers where each layer was compacted by 25 blows with a tamping bar. A general quality check was performed to improve the layers which were less compacted, minimizing any type of voids in the compaction.

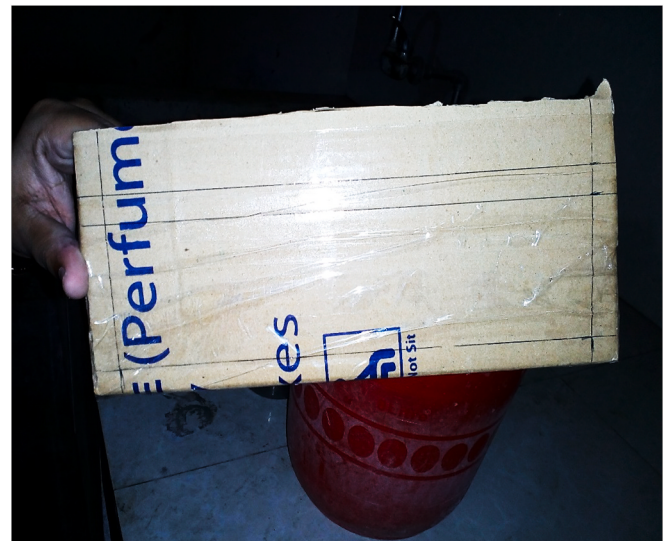
Fig. 6. Casing prepared by using a cardboard box with dimensions selected as  $(L \times B \times H = 9.5 \text{ in} \times 3.5 \text{ in} \times 3.0 \text{ in})$ .

Later, frames were assembled by utilizing cardboards which have been used to prepare each of the brick samples. The casing measurement was chosen as  $(L \times B \times H) = (9.5 \text{ in} \times 3.5 \text{ in} \times 3 \text{ in}) = (241 \text{ mm} \times 88.9 \text{ mm} \times 76.2 \text{ mm})$ . Cardboard was stiffened and severed according to the chosen mark dimensions and packing tape was assembled around the whole casing to bind it in the shape of a conventional clay brick. Followed by this procedure, each casing was prepared for the testing samples. Figs. 5 and 6 illustrate the sand filled PET bottle and cardboard frame used in this study to prepare plastic brick samples, respectively.

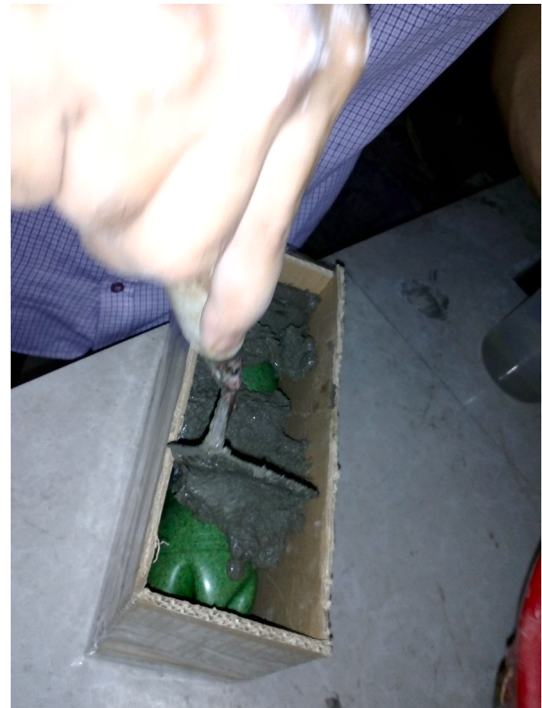
Fig. 7. Preparing a plastic brick sample with blended mortar cast in the cardboard frame and the PET plastic bottle set in the center.

The cement-sand blend utilizing water was prepared with mortar proportion and water-cement proportion of 1:2, respectively. The mortar was hand mixed with 15 min of blending. After the blend was completed, a layer of 0.5 in was cast in the base of the cardboard frame. At that point, the plastic bottle compacted with sand was put in the center of the casing such that 0.5 in clear cover can be kept on the rest of the faces of the frame. After that, the mortar was poured in the frame up to the marked dimensions (see Fig. 7). After the completion of pouring mortar, the plastic brick was kept in the laboratory room temperature of  $25^\circ\text{C} (\pm 2^\circ\text{C})$  for 24 h before unraveling it from the cardboard frame. A one-day period later the brick samples were brought out of the cardboard frame and submerged in fresh water for the curing purpose. A total 14 and 28 days of curing period were selected for the plastic brick samples, respectively (see Fig. 8).

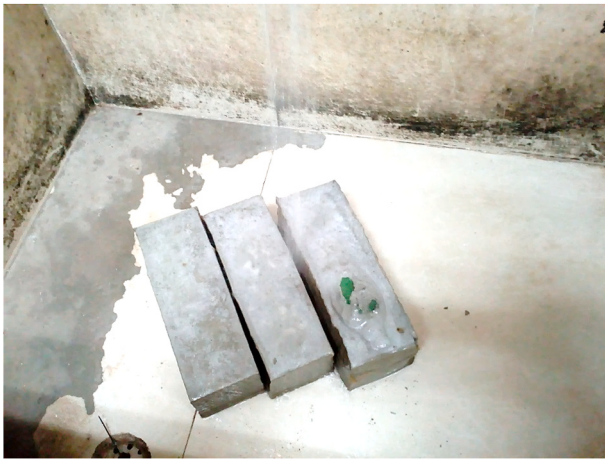
**Fig. 8.** Three plastic brick samples after removing from the cardboard case and completion of curing period of 14 and 28 days with a similitude like the normal clay brick.

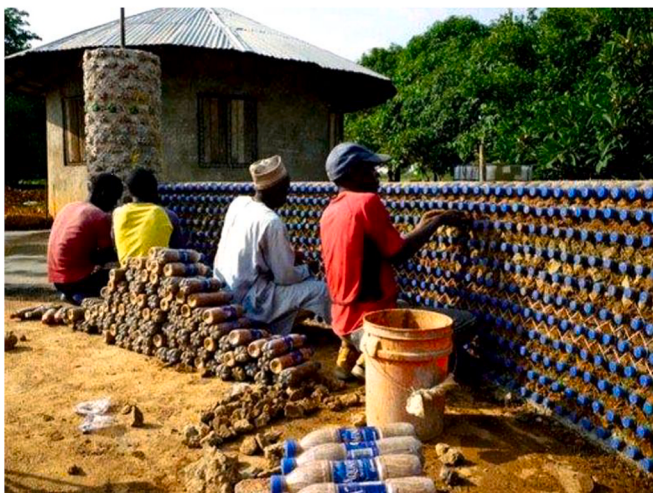
**Fig. 10.** Local people constructing their own living shelters by utilizing waste plastic bottle as plastic brick in Nevada (Haque, 2019).

large or medium stones will be placed and filled with cement-sand mix ratio of 1:7. This process will give the foundation for the proposed shelter to be constructed. Then, the plastic bricks prepared using the method of this study should laid down on the draft foundation, made of concrete. Only a maximum of 75% of the bricks need to be covered by the concrete at the bottom layer. Cob mixture can be used as mortar to bind the plastic bricks together and a layer of 5 cm should be maintained to lay the bricks on above another (Ecobricks, 2015, 2017). In case of unavailability or to reduce cost, clay can be used as mortar to bind the bricks in place (Wasteaid UK, 2017). This process will provide a strong wall structure for the shelters, capable of resisting the hazards induced by cyclones, mudslides, heavy wind, and rain. Moreover, the bottles can be replaced with another one in case of any damage to the used one. In the context of Bangladesh, it will cost only 2.32 BDT to prepare a plastic brick (Muyen et al., 2016), whereas a conventional brick costs only about 10.80 BDT (BBS, 2019), a cost-effective solution with suitable building materials for these refugee population. The process is so simple and easy that Rohingya refugees can prepare their own living shelters by themselves without any involvement of labor forces, externally (see Fig. 10).
